Chapter 7: Elements of Deterioration

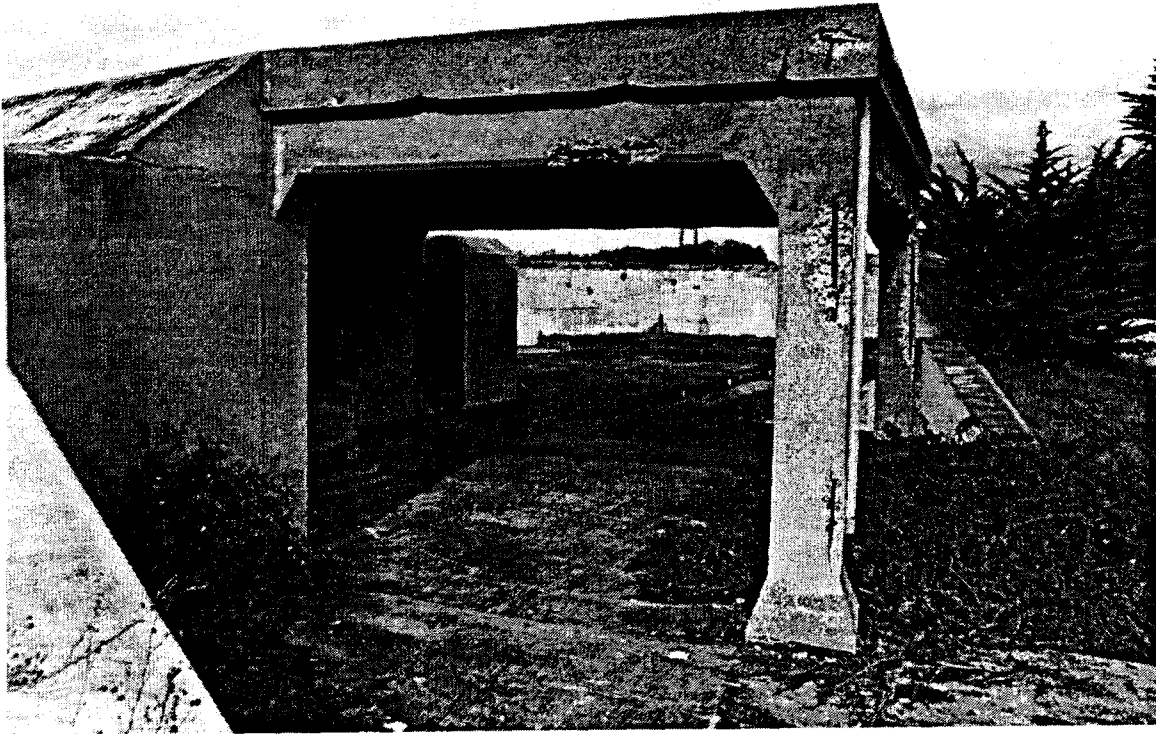
Plate 47. Concrete spalling is evident in the splinterproof at Battery Crosby, Fort Winfield Scott, constructed 1899-1900. Splinterproof added between 1904 and 1912.
